Machine Datasheet

George Fischer Diastar Valve with Position Indicator

Stock No MA744

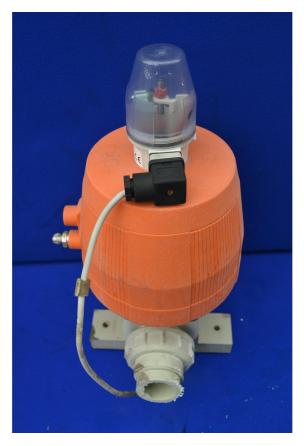
George Fischer Pneumatically Actuated Diaphragm Valve. DIASTAR with Electrical Switch Position Indicator.

Product description The DIASTAR 025 has the highest closing forces in the portfolio of pneumatically actuated diaphragm valves and is available with the fail safe to open function. The valve is thus used wherever high pipe pressures of up to 10 bar need to be controlled on both sides. Function Pneumatic diaphragm valves from GF Piping Systems are used for regulating, as well as closing, controlling and monitoring volume flows. Especially when transporting contaminated, aggressive or abrasive media, this type of valve has decisive advantages thanks to its simple function and optimized

construction. Only the valve body and diaphragm come into contact with the medium.

All valves are fitted with A George Fischer electrical position indicator, ER 52-1
