Machine Datasheet

Ryeford Engineering Pre-Inspection Wash Tank and Pall Stainless Steel Filter Housing

Stock No DA1415

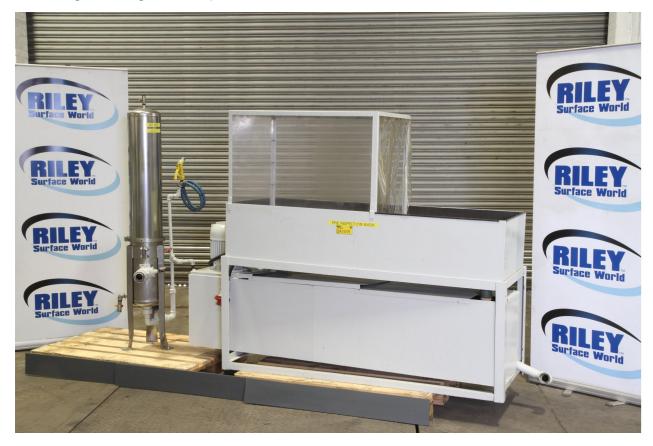
Pre Inspection Manual Wash Tank with Pall Stainless Steel Filter Housing

Work table starts in the load position where parts are laid out for initial debris removal, work table is then moved to an enclosed spray position.

Parts are then manually cleaned by operator with hand held spray lance.

Mild steel construction.

- Shuttle trolley is 470mm x 445mm x max height of 500mm.
- External tank dimensions: 2500mm x 750mm x 1580mm.

Pall Stainless Steel Filter Housing Cartridge Filter - LBV range Model LBV 64
