Machine Datasheet

Carter Environmental Thorn W120 Wet Collector

Stock No AAB700

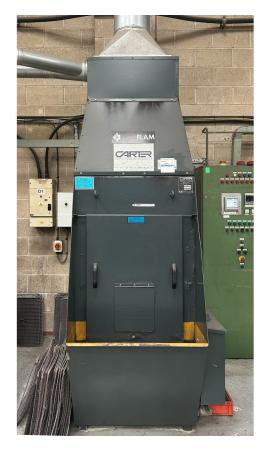
Second hand Carter Environmental Thorn W120 NonFlam 5.5 wet type dust control plant. Constructed from a carbon steel body with steel internal baffles.

A wet filter unit, sometimes known as a wet scrubber, typically separates solid particulate from the air stream by passing it through an atomized liquid whereby particles get encapsulated by droplets and then submerged into a tank where sedimentation occurs.

- Volume 4,000 m3/hr.
- Mild steel painted.
- Self-induced wet scrubbing always provides the full design air volume extraction rates (continuous extraction).
- Fan set built-in with anti-spark feature and silencer.
- Complies with health and safety guide HSG258.
